**Report**

Root cause analysis Blackout events

December 2020

Ref nr. 2021-4027

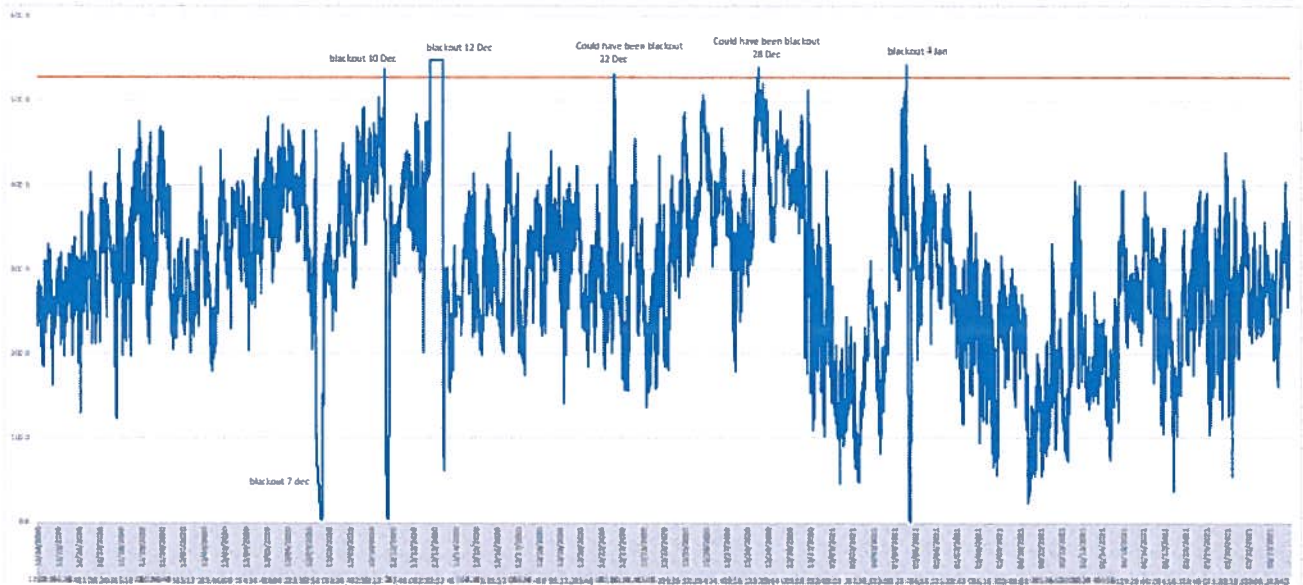
**Figure 4: ISLA - DOKWEG 66kV cable load**

As a common factor between the December 10<sup>th</sup>, 12<sup>th</sup>, and January 4<sup>th</sup> event was found to be the disconnection of bay F04 at the Dokweg 66 kV substation (DIgSILENT: Analysis of Grid events -10.12.2020 & DIgSILENT: Analysis of Grid events -12.12.2020). This disconnection resulted in the Dokweg II A&B plant to be fully disconnected from the grid hence leading to the loss of frequency control in the grid. Since the UFLS could not deal properly with the sudden loss of load, this resulted in a series of blackouts.

Preliminary investigation by DNV-GL based on information obtained from AQ indicated that the cable protection system (P521) triggered the disconnection of bay FS04 (DNV-GL Memo dd 09.01.2021). Since there was no probable cause for the P521 to trigger, AQ requested Schneider to perform a local investigation of the protection system of the 66 kV substation. Schneider is the supplier of the protection system of the 66-kV switchgear which was supplied by K-Line. Further investigation of the root cause of the disconnection of the FS04 bay (Schneider Electric: Aqualectra Blackout investigation report, 14.01.2021) indicates that the protection system P139 was triggering and causing the bay FS04 to disconnect.

- a) The event of December 7<sup>th</sup> is visible in the load of the cable
- b) The event of December 10<sup>th</sup> is visible, and it coincides with a load exceeding the 528 Amps
- c) The event of December 12<sup>th</sup> is visible, and it coincides with a load exceeding the 528 Amps
- d) On December 22<sup>nd</sup> there was a "near" miss since the load exceeded the 528 Amps, but the "overloading" did not last enough to cause a trip event
- e) On December 28<sup>th</sup> there was a "near" miss since the load exceeded the 528 Amps, but the "overloading" did not last enough to cause a trip event
- f) The event of January 4<sup>th</sup> is visible, and it coincides with a load exceeding the 528 Amps

When performing a blackstart in the Curacao power grid, the energizing of the 66kV grid starts by blackstarting the 66kV transformers at DPP at ISLA and the Parera. This was not done during the December 7<sup>th</sup> blackstart. Reason for this being that the root-cause of the December 7<sup>th</sup> event was not known at the time of the blackstart. For this, it was opted not to soft start the Loadcenter Parera. This caused all the generated capacity from the Dokweg II plant to flow through the ISLA 66 kV substation to the island grid. This caused the load on the cable to increase.

After the root cause analysis by Schneider (Schneider Electric: Aqualectra Blackout investigation report, 14.01.2021), the Parera transformer was soft started on January 10<sup>th</sup>, 2021 (in the morning hours). With this the first step of the correction of the root cause of the repeated blackouts of December 10<sup>th</sup>, 12<sup>th</sup> and January 4<sup>th</sup> was corrected. Still remains the protection system analysis to set the protection system of both the P139 and the P521.

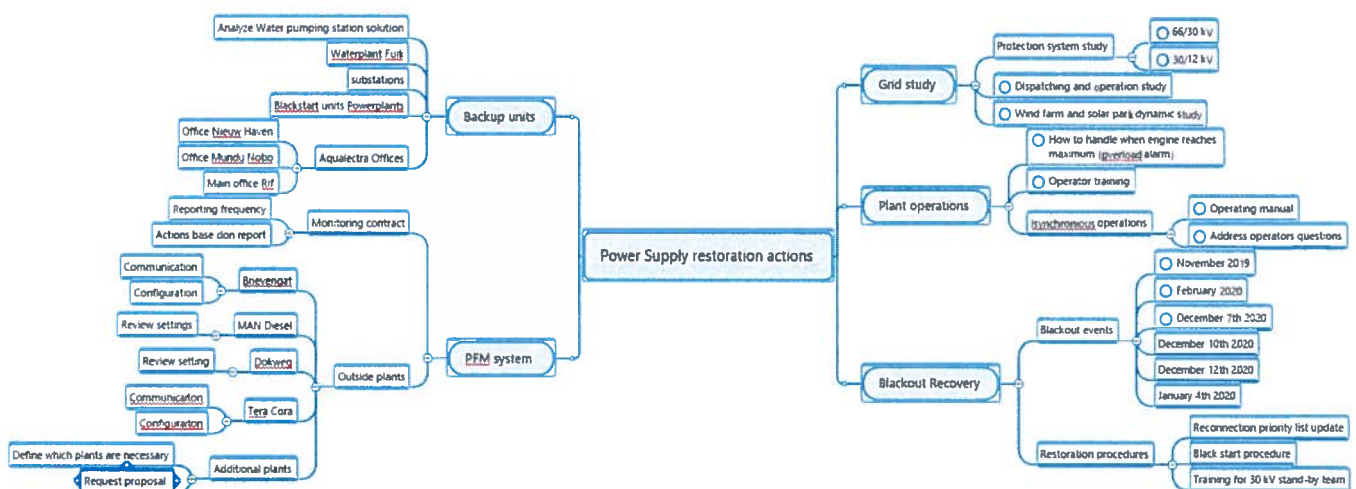
**Figure 5: Mind Map Blackout restoration events**

An approach to guiding the realization of all the required actions resulting from the blackout events is reflected in figure 5. Based on these analyses by the various internal and external subject matter experts the following recommendations have been issued and the corresponding action has been taken based there on:

- a) Finalize the implementation of the Isochronous project and document the working of the system.
- b) (Re)Train the operators in:
  - a) Plant operations
  - b) Operations of the Isochronous operating system
  - c) Transport grid understanding and management
  - d) Calculating and maintain spinning reserve capacity
- c) Blackstart unit at DPP (blackstart location)  
The connection of this unit to the plans should be revised/ replaced as well as the capacity of the unit should be increased to be able to load up the plan as well perform soft-start of the transformers Weis and Parera simultaneously
- d) Backup generators at each powerplant  
All the backup generators at Dokweg I&II as well as Mundu Nobo (GT-II) should be revised and kept in optimal running condition at all times.

- c) Blackstart units and backup units for the standard functionalities  
The following blackstart and backup units need to be tested and replaced for proposer functioning:  
All the backup generators at Main office Rif and Nieuwe Haven should be revised and kept in optimal running condition at all times.

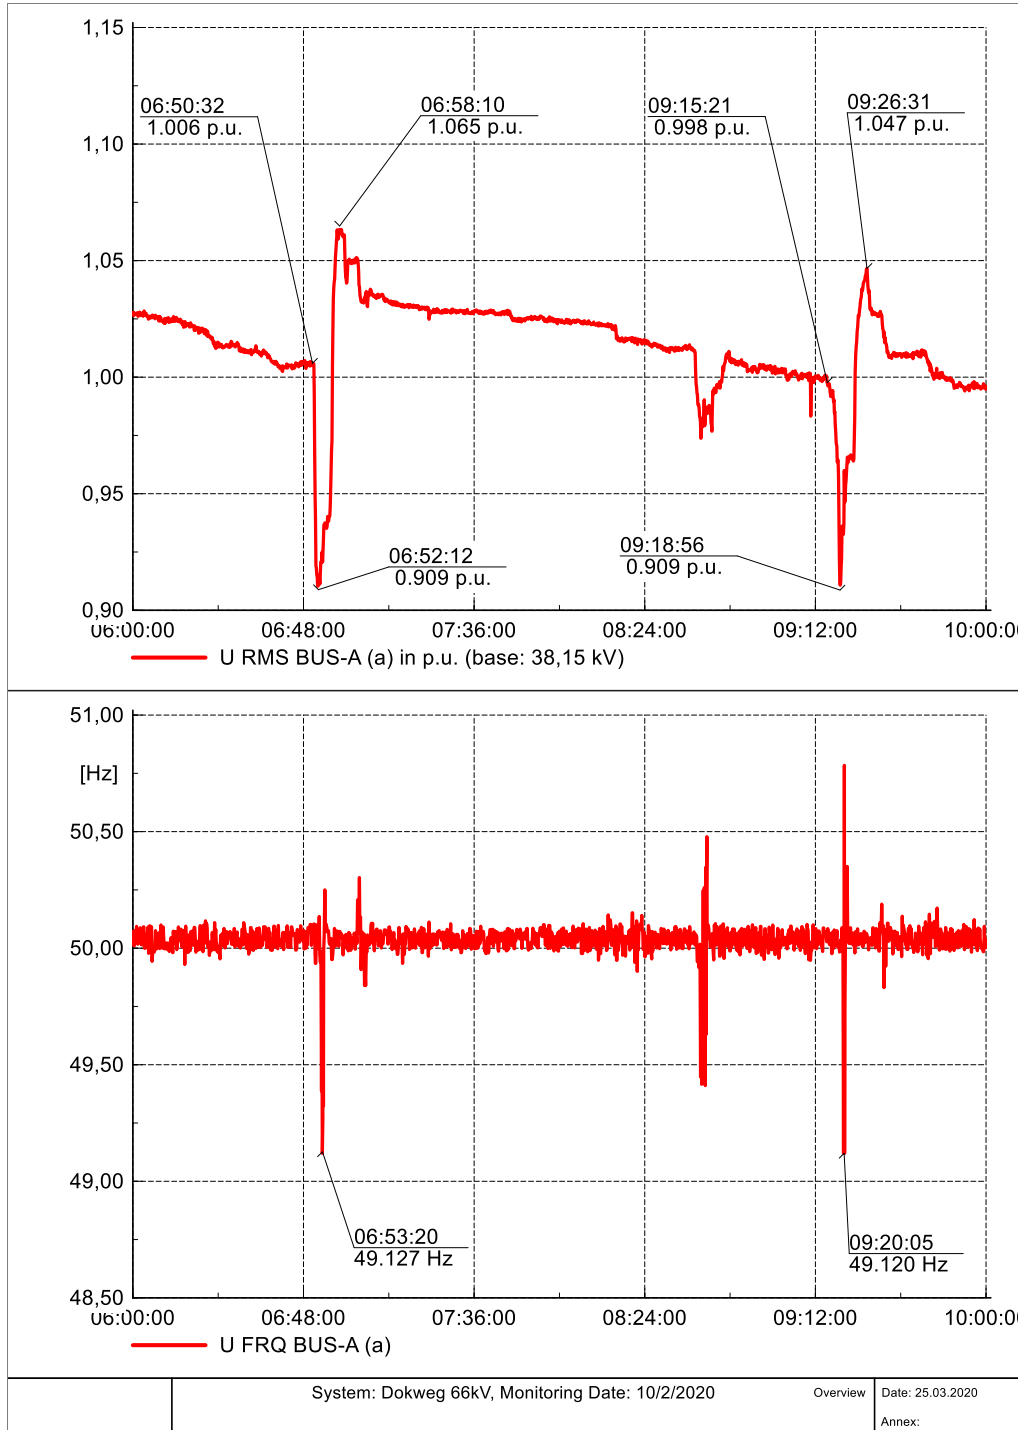
Figure 3-1: Overview of events on the 10<sup>th</sup> of February 2020 – Dokweg 66 kV – Voltage (up) and frequency (bottom)

As shown in Figure 3-1, voltage and frequency drop significantly (voltage drops down to ~0,9 p.u.) twice in a time frame of four hours.

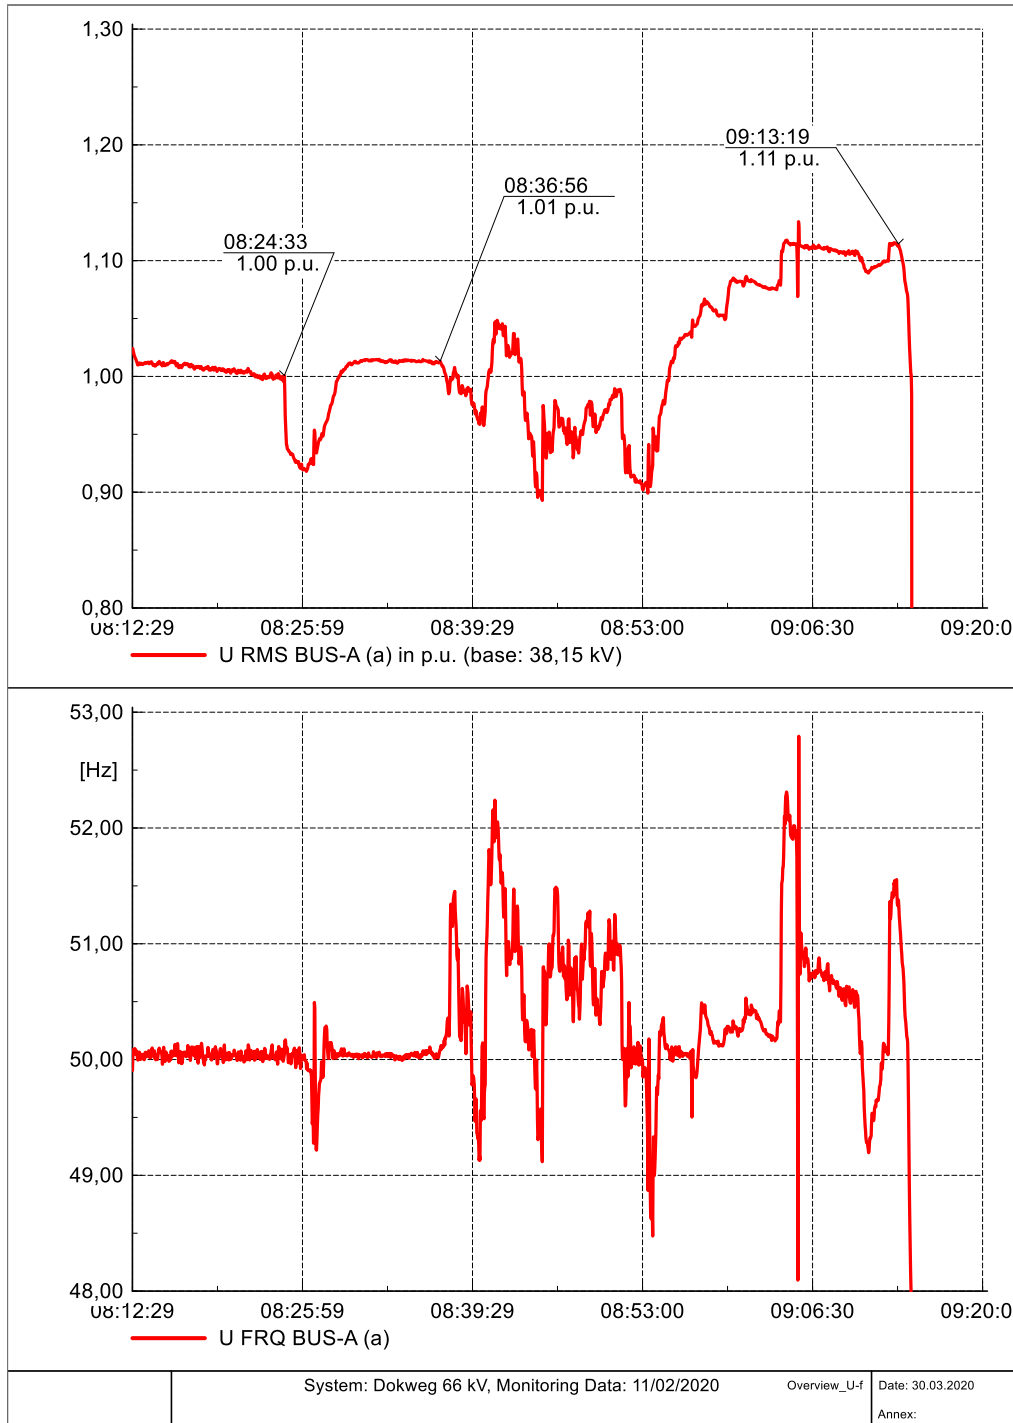
Figure 4-1: Overview of events on the 11<sup>th</sup> of February 2020 – Dokweg 66 kV – Voltage (up) and frequency (bottom)

As shown in Figure 4-1, a drop in voltage occurs at approximately 08:24 hours. After 08:36 hours, system starts to show instabilities in both voltage and frequency, and eventually system collapses (09:13 hours)

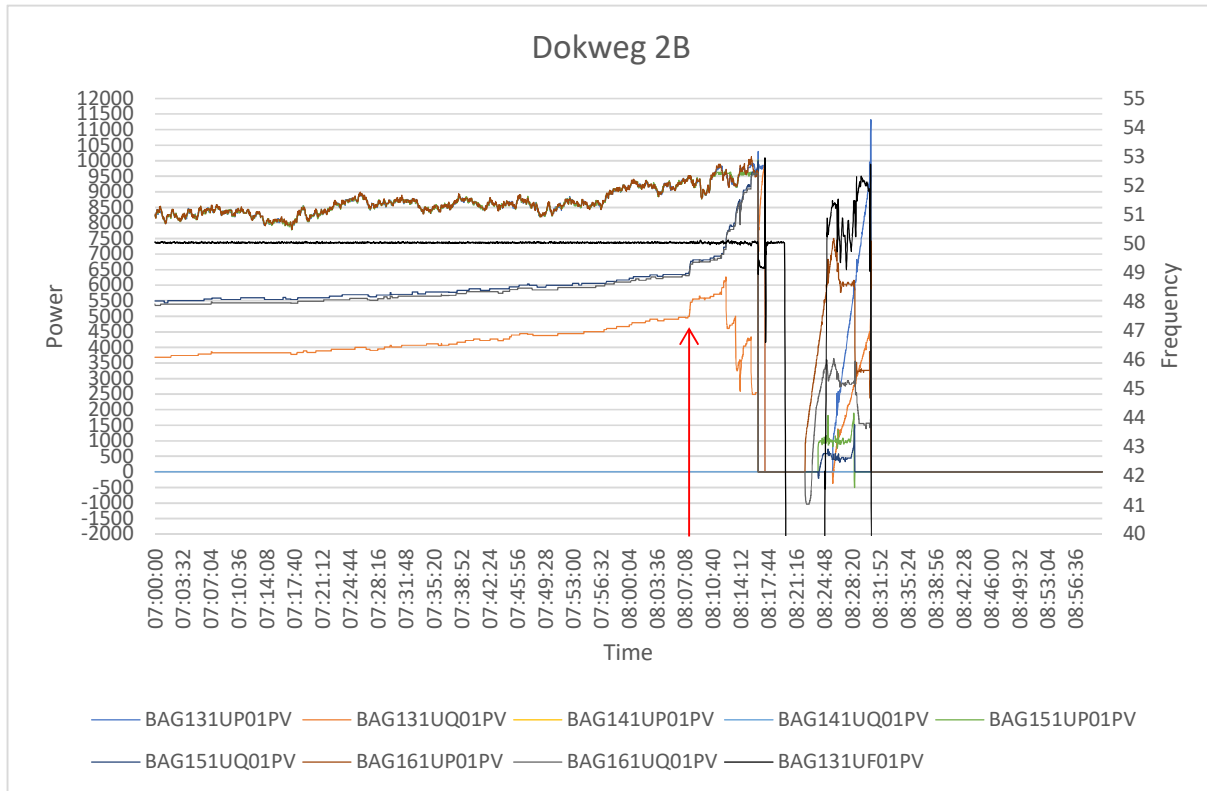
Wärtsilä responds to this statement that isochronous mode is tested, and engines will not overload as the mechanical limiters have been adjusted correctly. However, operators decided to switch to kW-operation anyway.

Figure 2. Dokweg 2B, Engine active, reactive power and frequency from 07:00 to 09:00

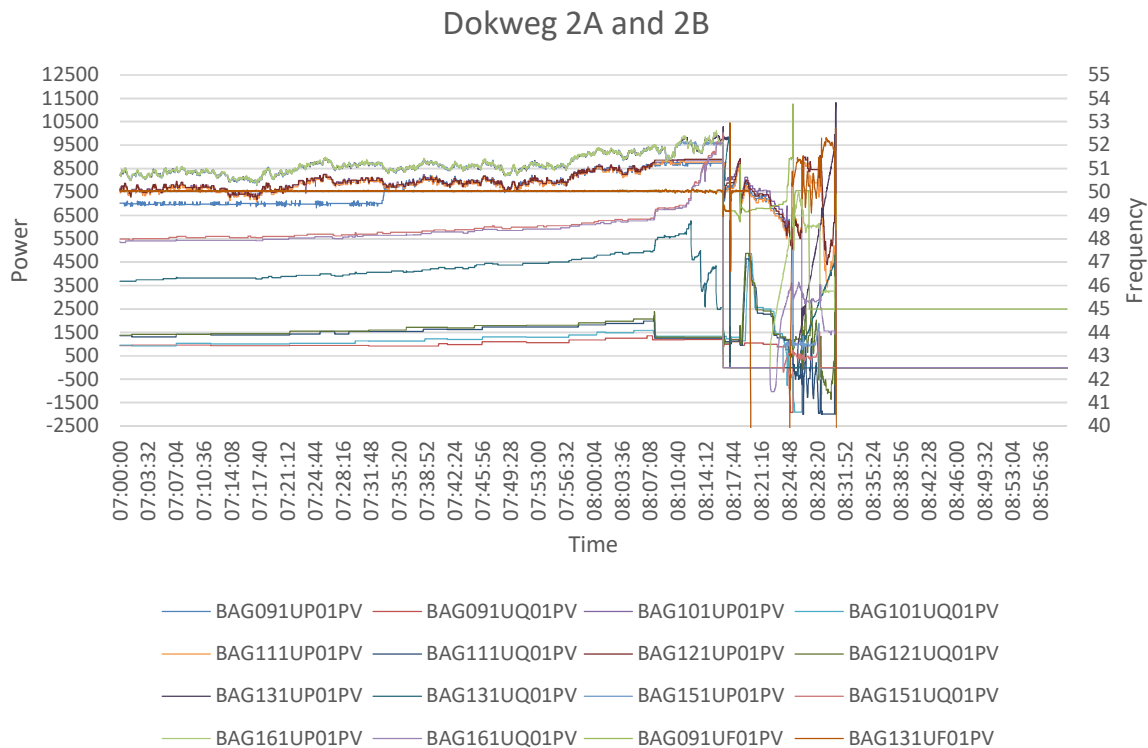
Figure 3. Dokweg 2A and 2B, Engine active, reactive power and frequency from 07:00 to 09:00

At 08:17-08:18 Engines 15 and 16 trips due to overcurrent what leads to sudden frequency decrease and system voltage decrease. Eventually these events lead to system blackout in Dokweg 2A and 2B even the fast re-start of engines 13,15 and 16 which was not able to support the system sufficiently.

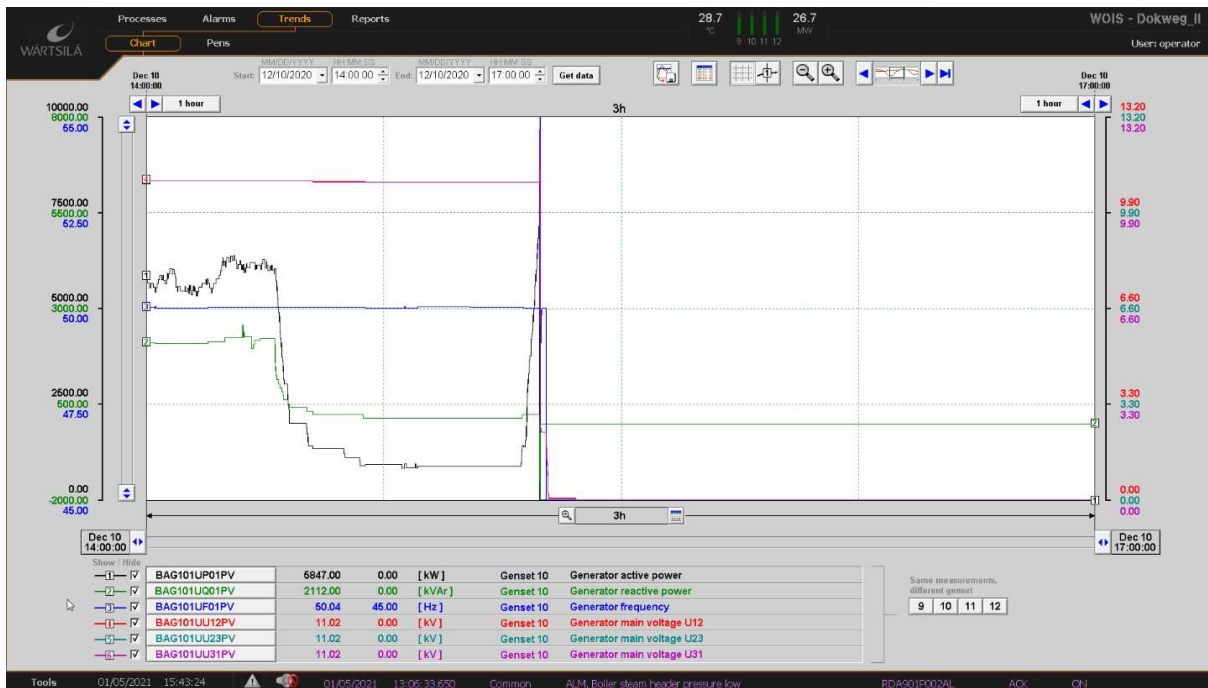
Figure 1 Engine 10 turbo washing.

- Engine 10 turbo washing December 10<sup>th</sup>, 2020, 14:24:14 engine mode to kW and P.F
- 14:31:20 turbine wash active. Load 1300 kW.
- 15:11:06 turbine was completed.
- 15:11:55 engine set Isochronous operation from WOIS. Load ramping from 1300 to 7250 kW.
- 15:14:38 trip from reverse power. Auto stop active in several cylinder temps. Probably caused high ramp rate after turbo washing. B3 cylinder temp deviation alarm active longest time.

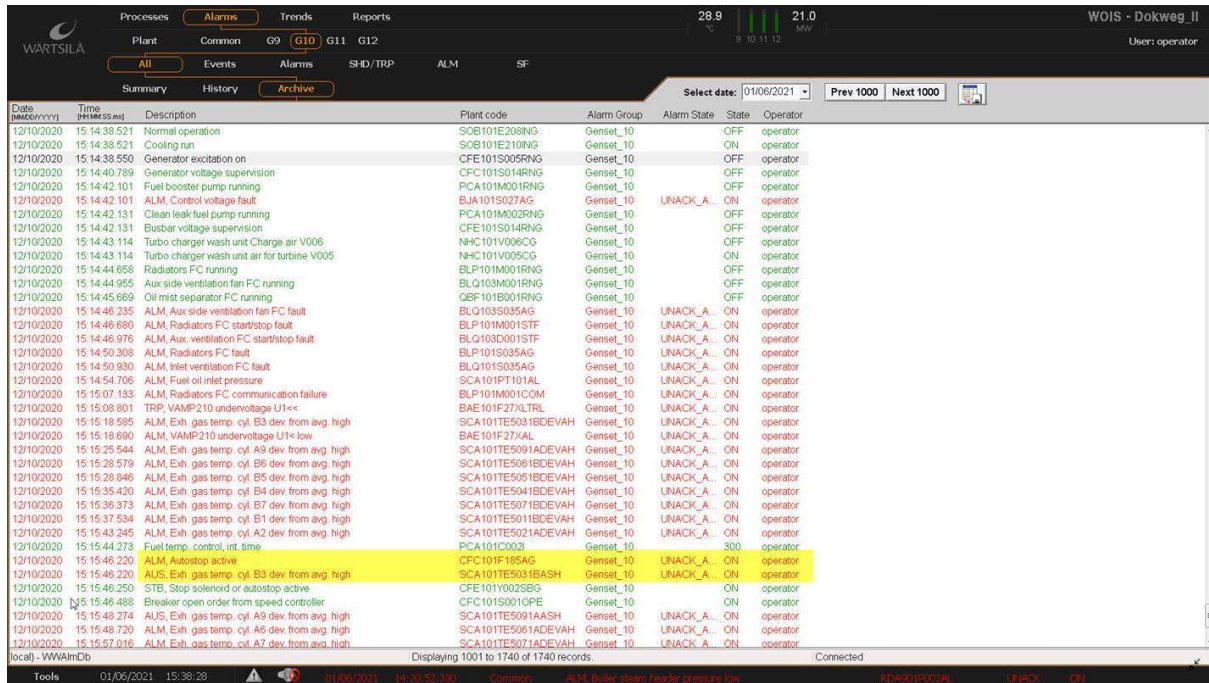
Figure 7 Auto stop active in several cylinders. Too high deviation in exhaust gas temp. B3!

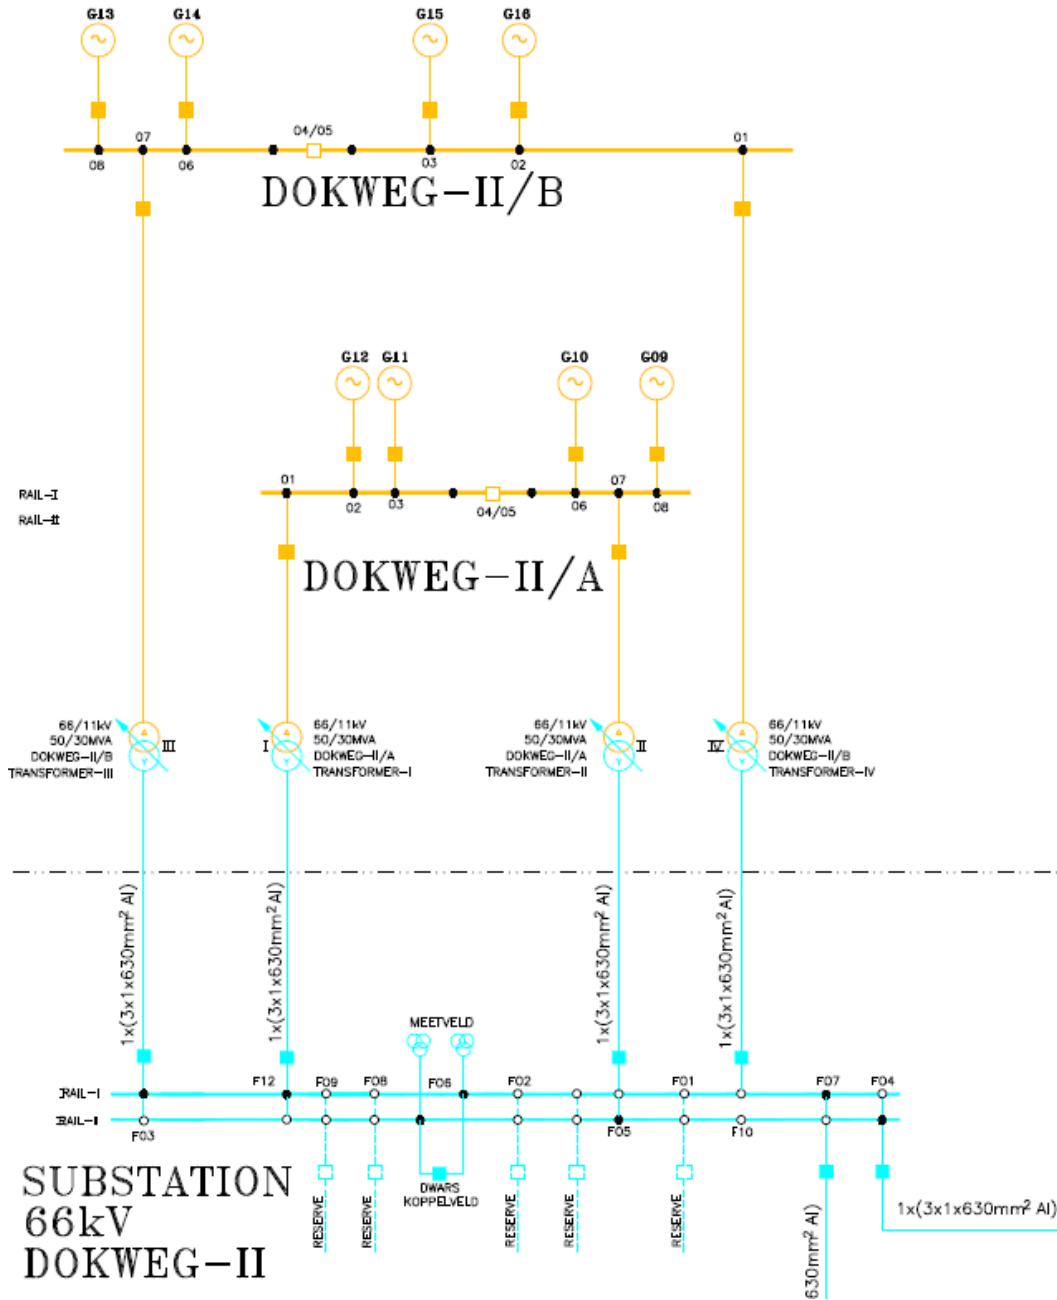
During the email exchanges that were had with Aqualectra, we were told that the circuit breakers that operated were Bay 03, Bay 04 and Bay 10. The breaker that caused the blackout was Bay 04, and upon starting up the system after the blackout, on some instances Bays 03 and 10 operated (see below SLD):

Bay 03 and Bay 10 are incoming from the 11kV Dokweg-II/B substation and Bay 04 is a feeder that goes to the 66kV Isla substation. It is important to note that when this project was delivered on 2015, there was only the Dokweg-IIA substation. On 2019, Aqualectra added the Dokweg-IIB substation and converted two of the bays of the 66kV GIS SWG from feeder bay to transformer bays. These two bays that were transformed are bays 03 and 10, which are the ones that tripped during the start-up of the system after the blackout caused by the operation of Bay 04. Since the P746 busbar protection relays were off during the January 4<sup>th</sup> blackout, the plan was to connect to the protection relays in the affected bays (03, 04 and 10) in order to extract the settings, logic, events and disturbance records in order to analyze what the relays did during these blackouts and try to find the cause of the trip.

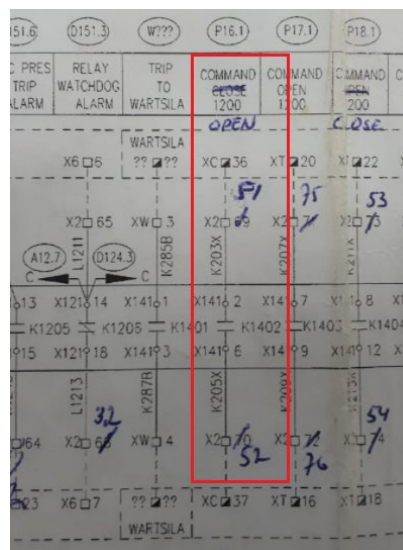
When we discussed with Aqualectra about the transformation of Bays 03 and 10 during the addition of the Dokweg-IIB substation and we were told that those two bays were rewired exactly as Bays 05 and 12 (which were two original Transformer bays from when the project was first delivered). We then asked to see the drawings that were used for this rewiring and we discovered that there was an wiring error and that in fact Output relay K1402 was wired to an open command to the circuit breaker:

Figure 12 - Output relay K1402 going to Open command
