**Report**

Root cause analysis Blackout events

December 2020

Ref nr. 2021-4027

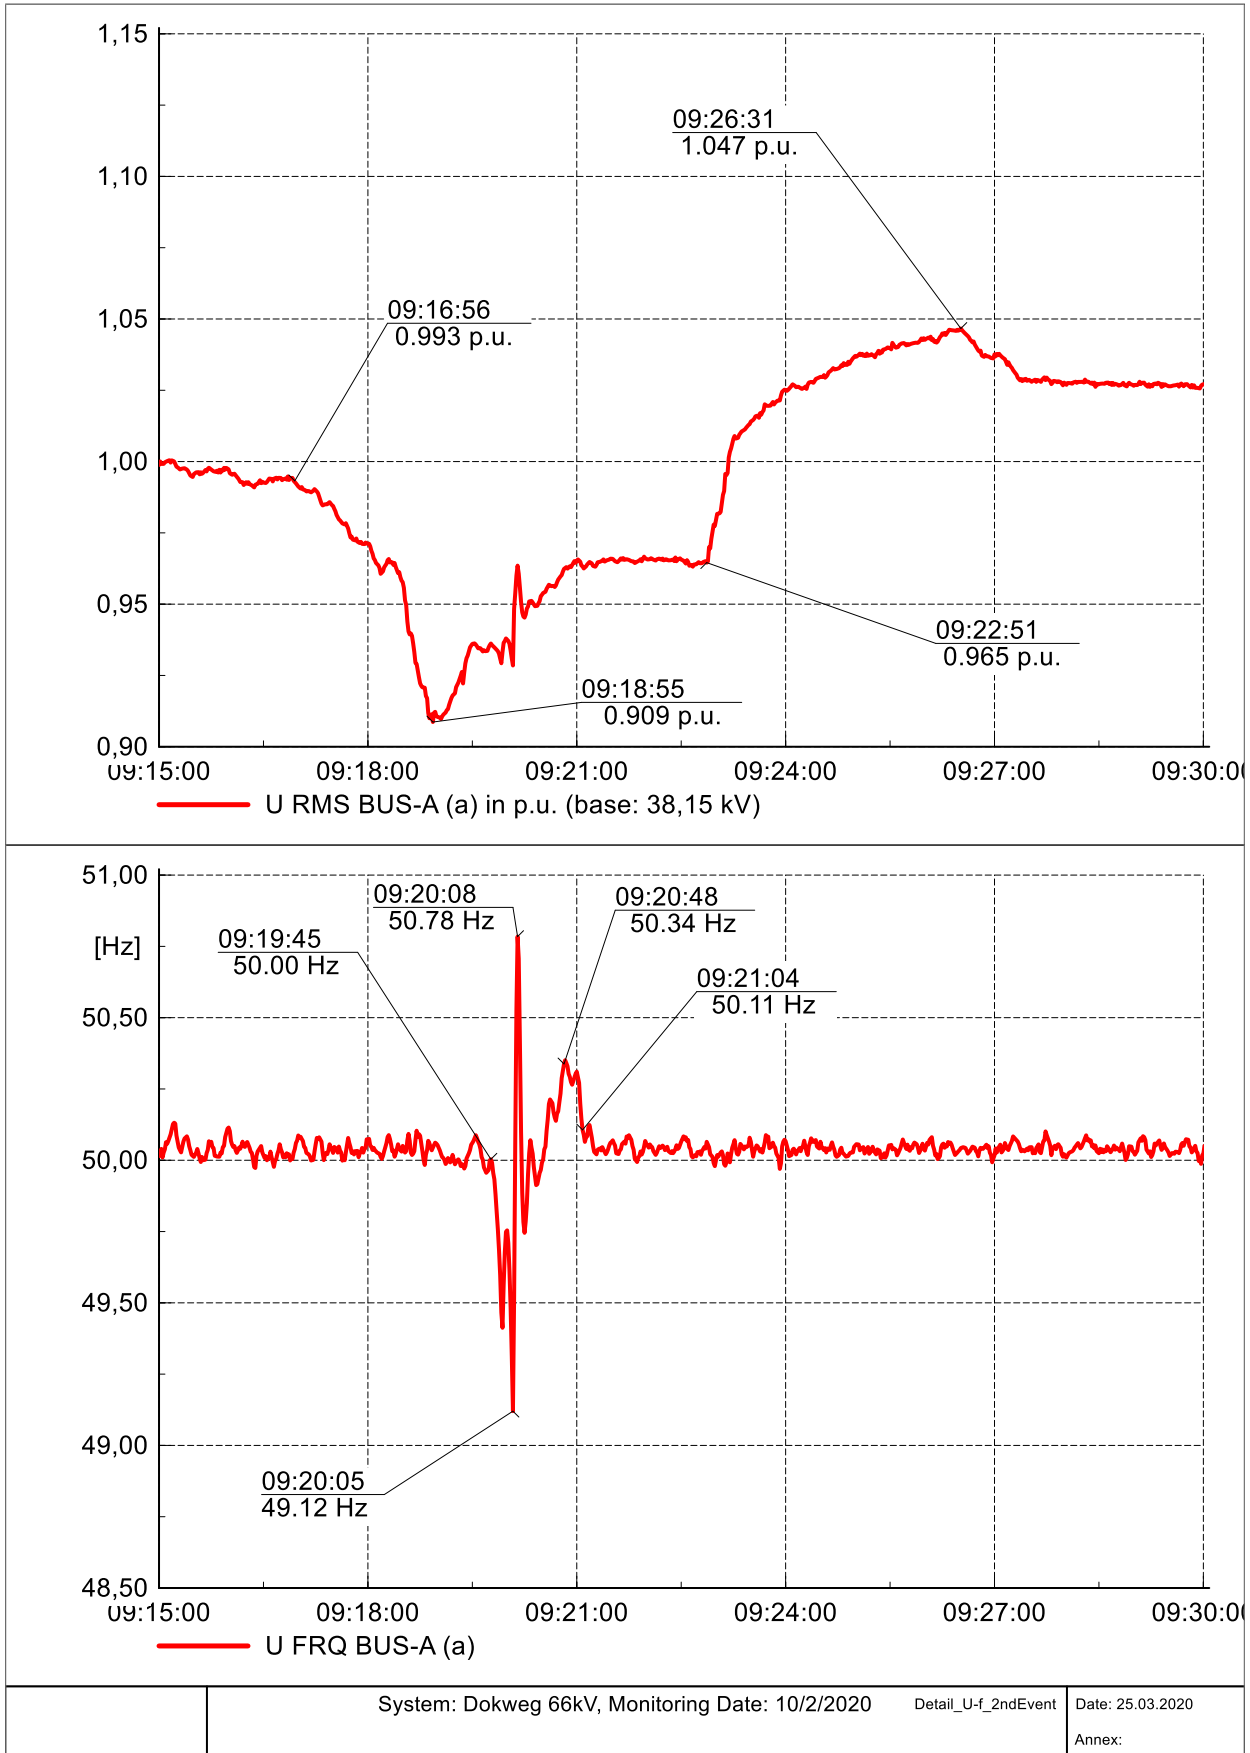
Figure 3-7: 2<sup>nd</sup> event on the 10<sup>th</sup> of February 2020 – PFM Dokweg 66 kV – Voltage (up) and frequency (bottom)

- Signal DOKWEG II-T2 shows a measured current of approximately zero, hence it is assumed that units 11 and 12 in Dokweg 2B are disconnected at the time of the event
- Signal Spare CT 1 shows no measurements, hence it is assumed that units 13 and 14 in Dokweg 2B are disconnected at the time of the event
- The bus coupler is closed at the time of the event
- Lines to substations Isla 66 kV and Parera are in operation at the time of the event \_pu

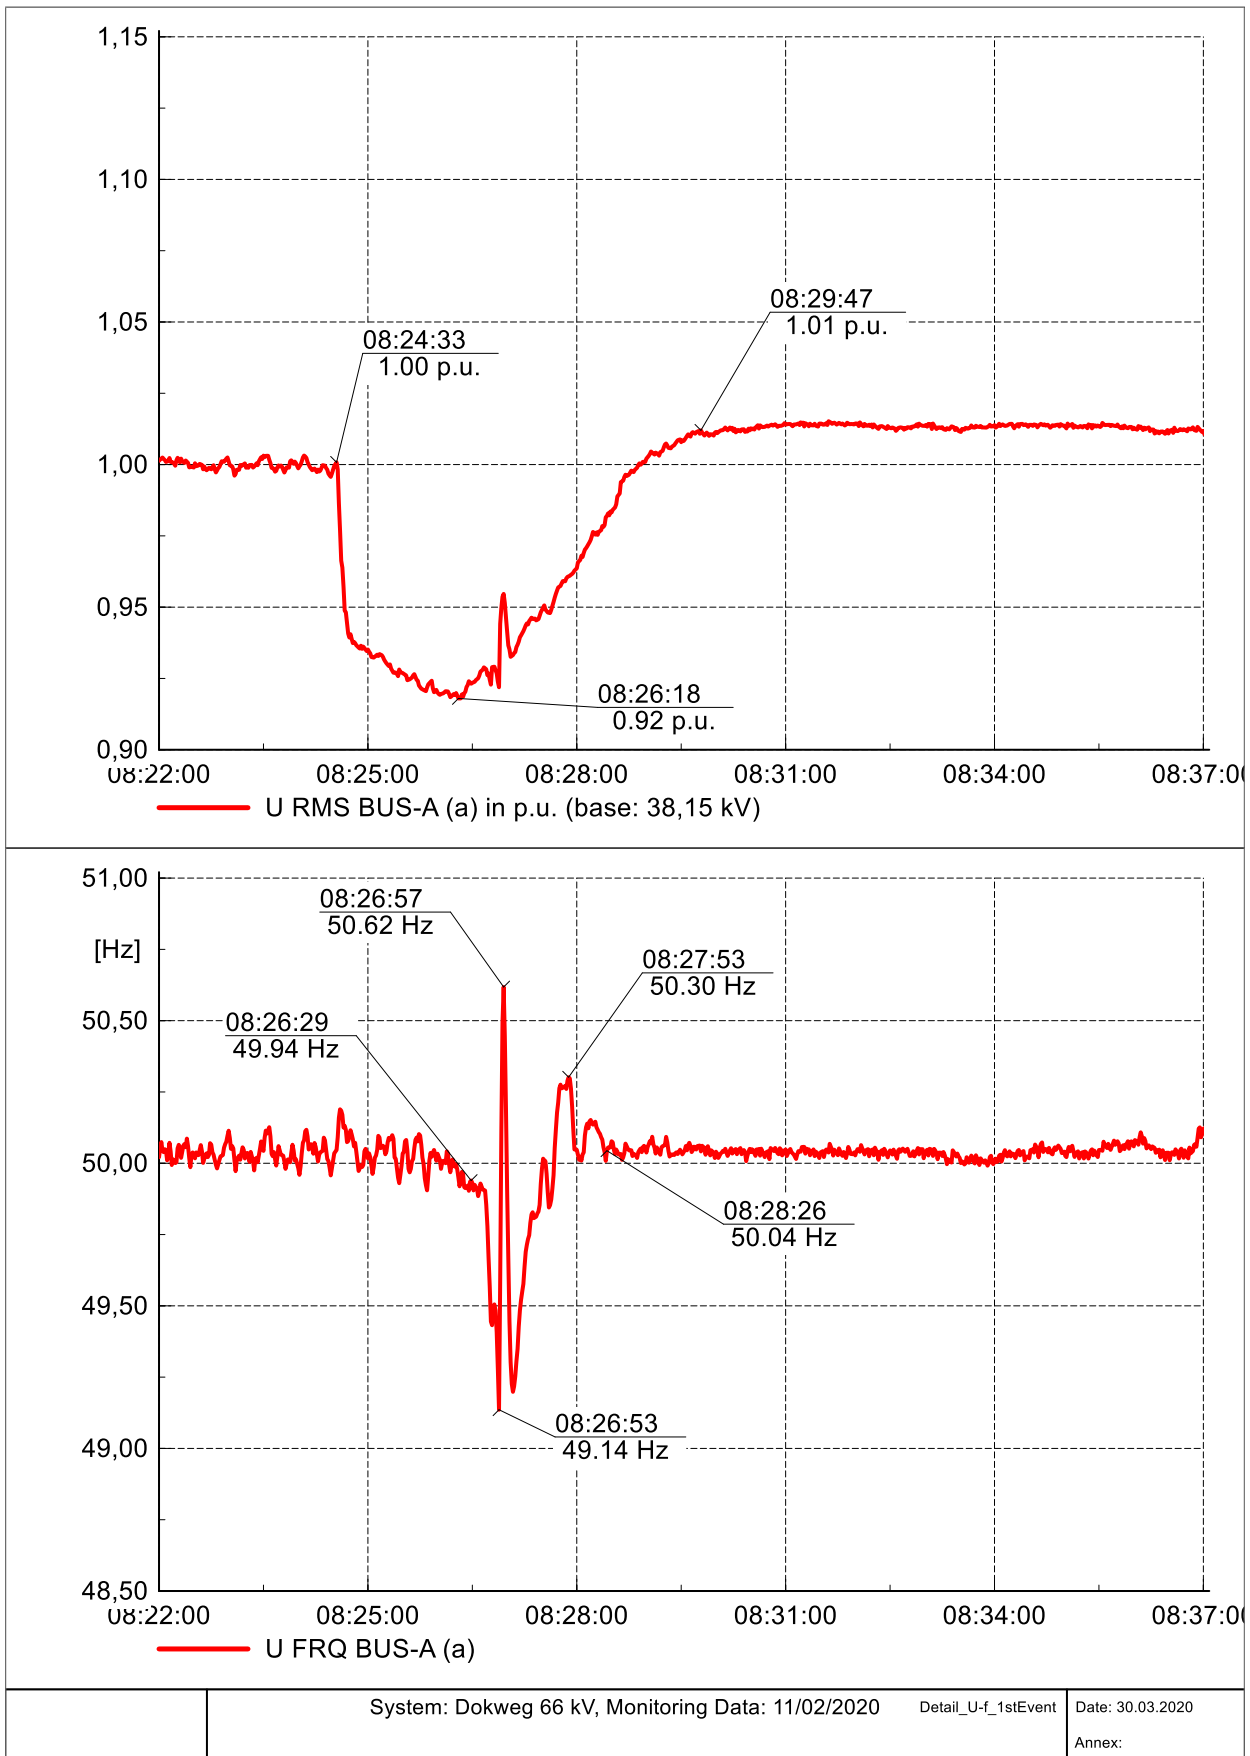
Figure 4-2: 1<sup>st</sup> event on the 11<sup>th</sup> of February 2020 – PFM Dokweg 66 kV – Voltage (up) and frequency (bottom)

- Signal DOKWEG II-T2 shows a measured current of approximately zero, hence it is assumed that units 11 and 12 in Dokweg 2B are disconnected at the time of the event
- Signal Spare CT 1 shows no measurements, hence it is assumed that units 13 and 14 in Dokweg 2B are disconnected at the time of the event
- The bus coupler is closed at the time of the event
- Lines to substations Isla 66 kV and Parera are in operation at the time of the event

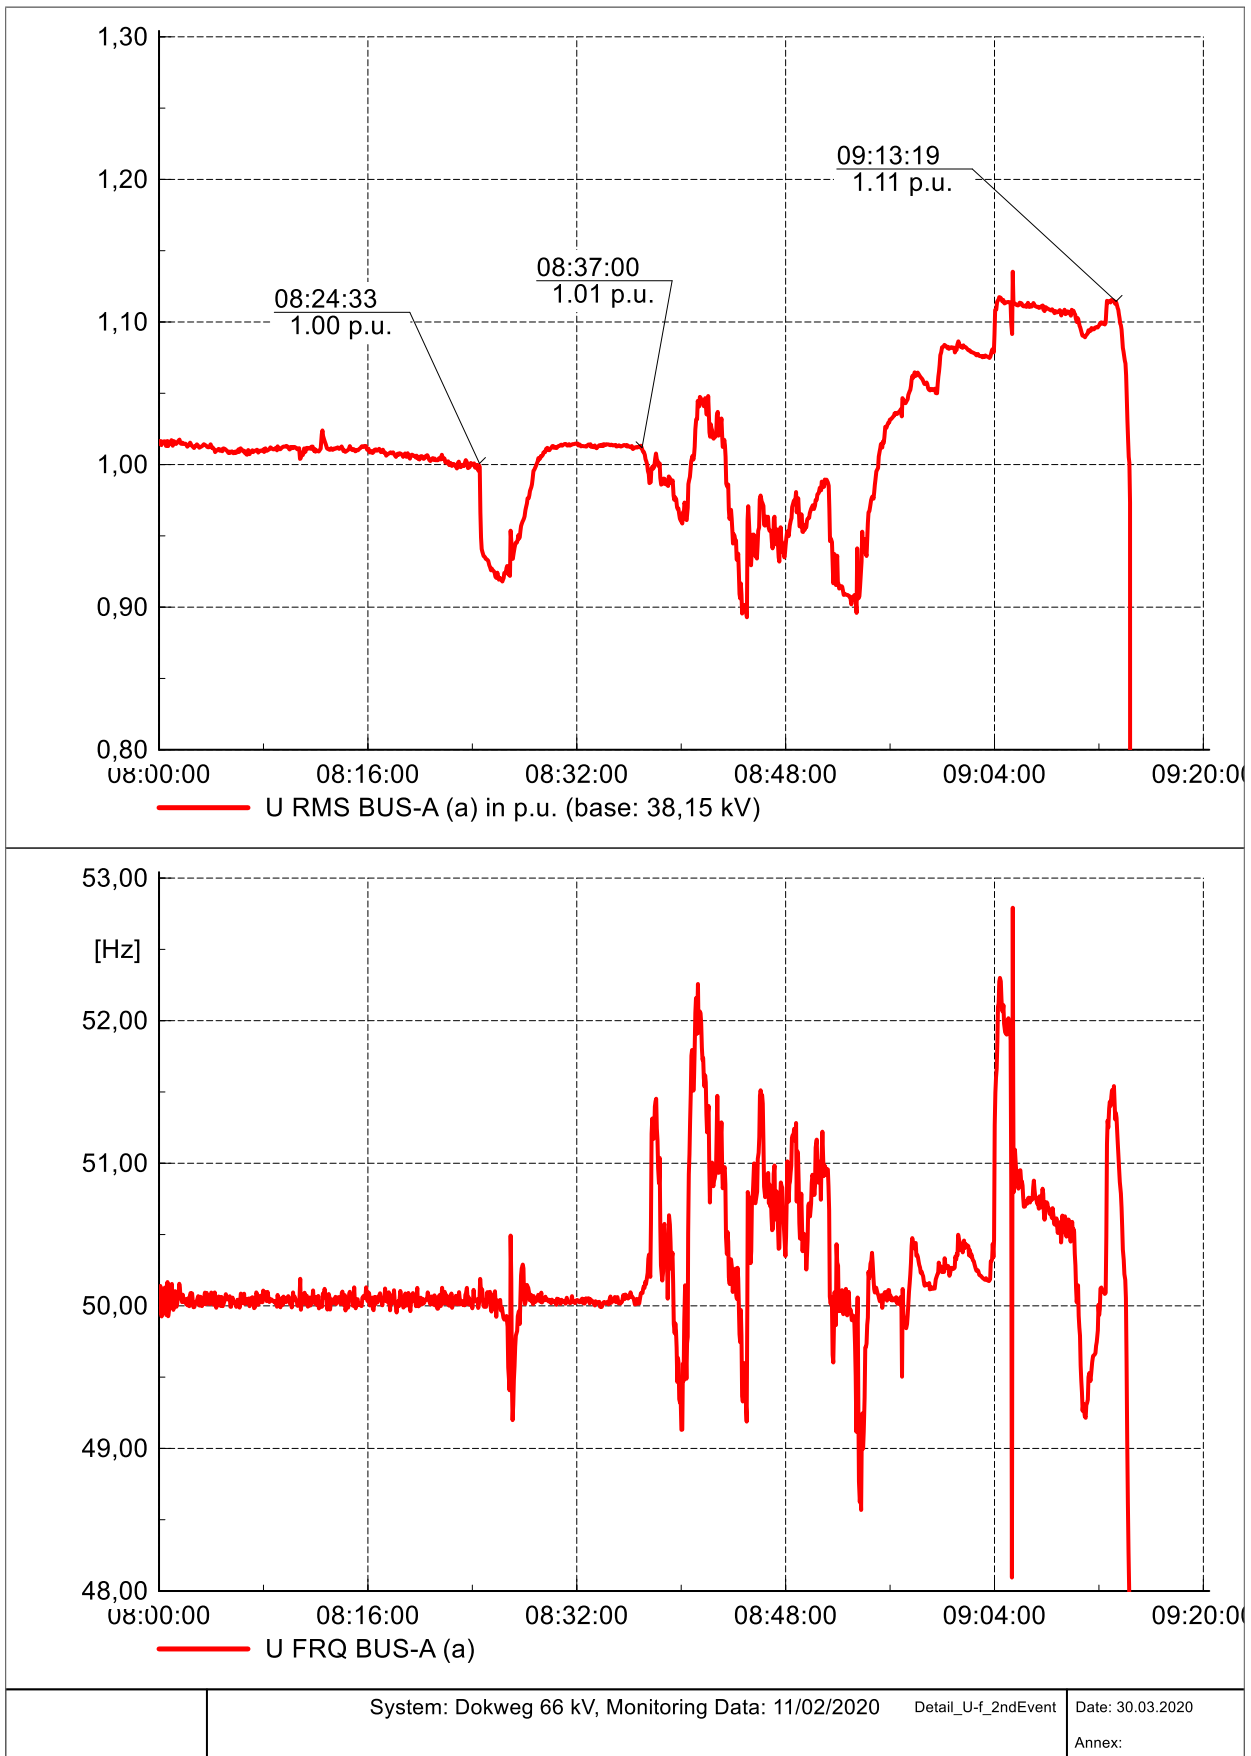
Figure 4-7: 2<sup>nd</sup> event on the 11<sup>th</sup> of February 2020 – PFM Dokweg 66 kV – Voltage (up) and frequency (bottom)

- Signal DOKWEG II-T2 shows a measured current of approximately zero, hence it is assumed that units 11 and 12 in Dokweg 2B are disconnected at the time of the event
- Signal Spare CT 1 shows no measurements, hence it is assumed that units 13 and 14 in Dokweg 2B are disconnected at the time of the event
- The bus coupler is closed at the time of the event
- Lines to substations Isla 66 kV and Parera are in operation at the time of the event

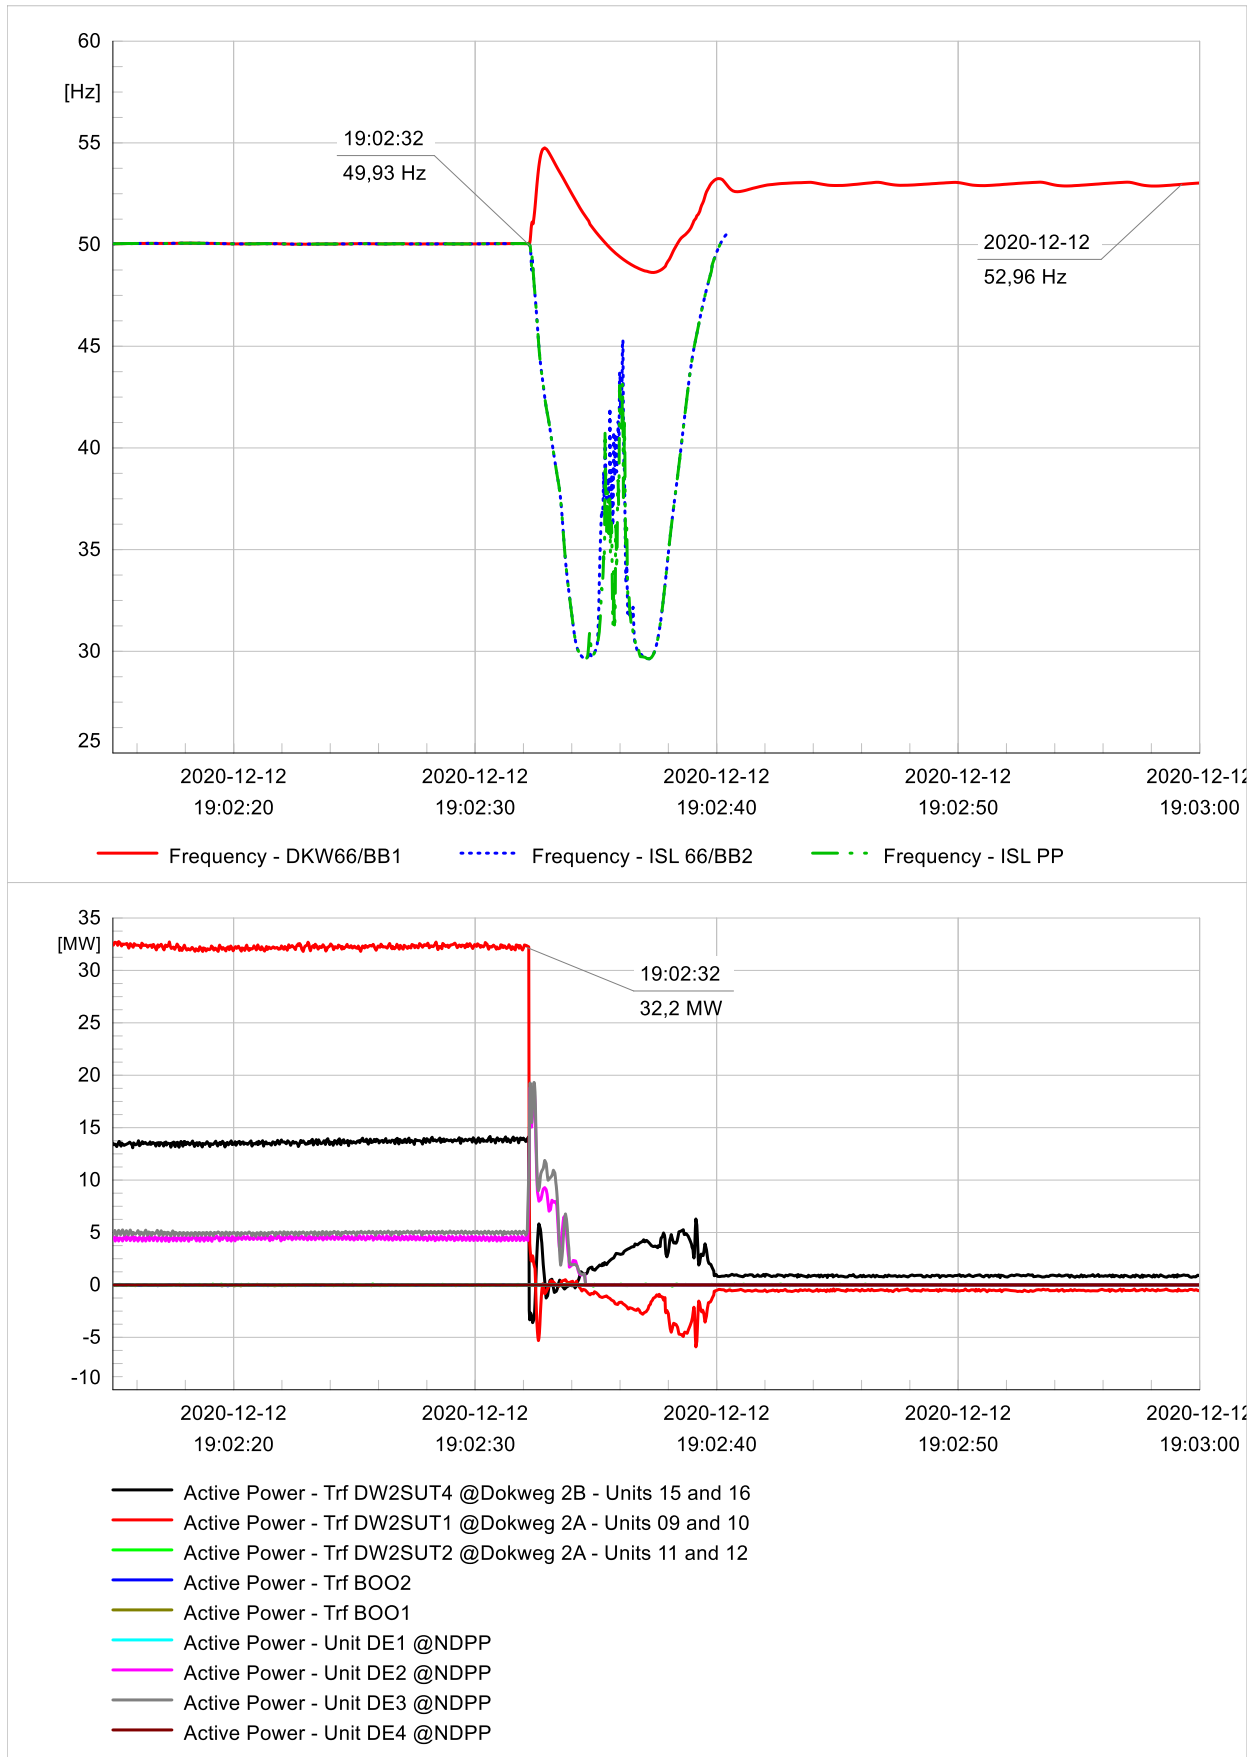
19:02:32	<p>Trip of line Dokweg 66kV-Isla 66 kV when the power flow is 63,8 MW. Subsequent investigations [9] have determined that the root cause is the activation of the overcurrent protection P139 in this line, adjusted at <math>0,88 \cdot I_n</math> (<math>\sim 63</math> MW), which is consistent with the power flow measured at the line right before tripping. These settings trip the line when the current exceeds 88% of the rated current, i.e. before reaching 100% loading of the line. More information about the protection settings is included in Annex D.</p> <p>Since this is the only line connecting Dokweg 2A and 2B power plants to the rest of Aqualectra power system, both systems separate and different frequencies are observed: fast increase in the Dokweg 2A and 2B side, and fast decay in Isla 66 kV and Isla NDPP.</p> <p>As a result, UFLS is triggered and substantial loss of demand is observed. Despite this, system is not capable of stabilising and frequency keeps decreasing, followed by a system blackout.</p>

Figure 4: PFM Recordings - Frequency and Active Power – From 19:02:15 to 19:03:00 hours

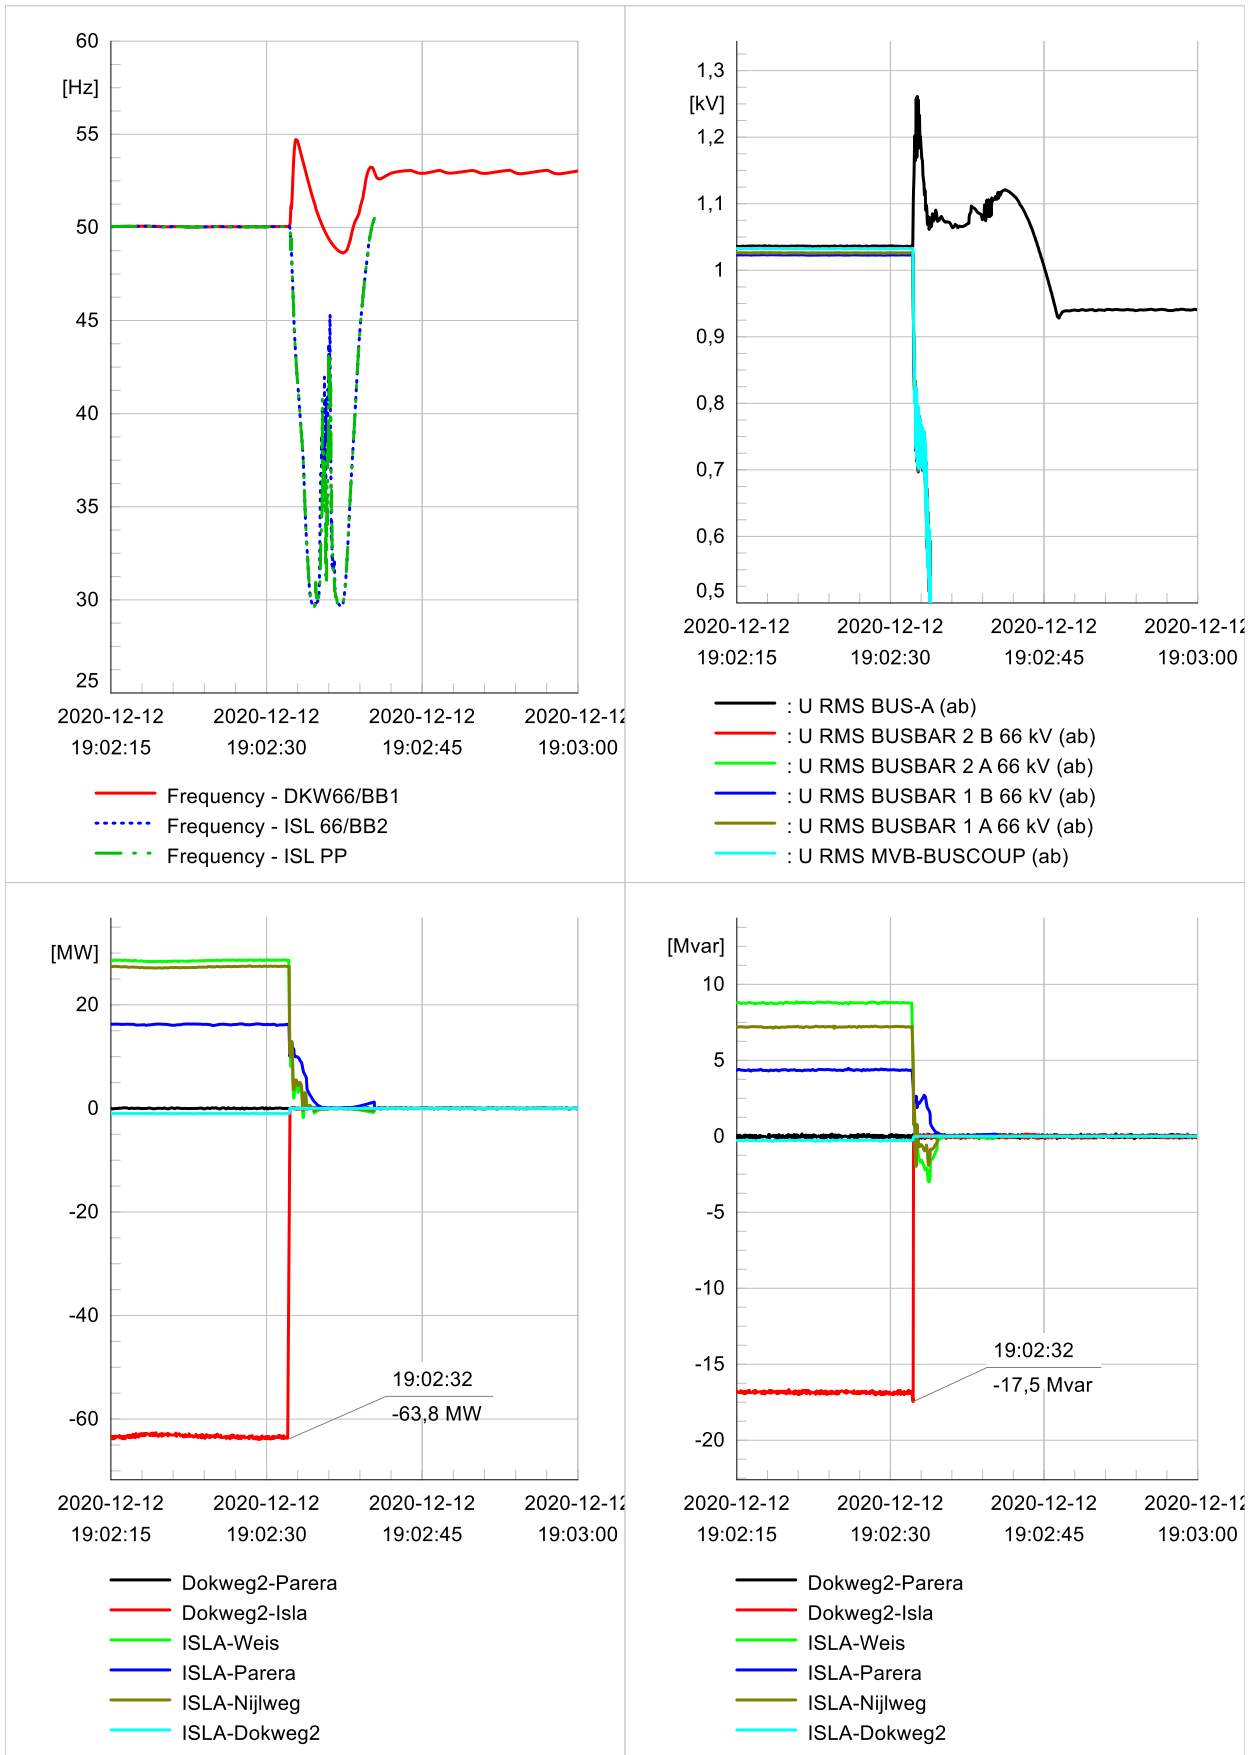
Figure 6: PFM Recordings – Frequency, Voltage and Power across Lines– From 19:02:15 to 19:03:00 hours

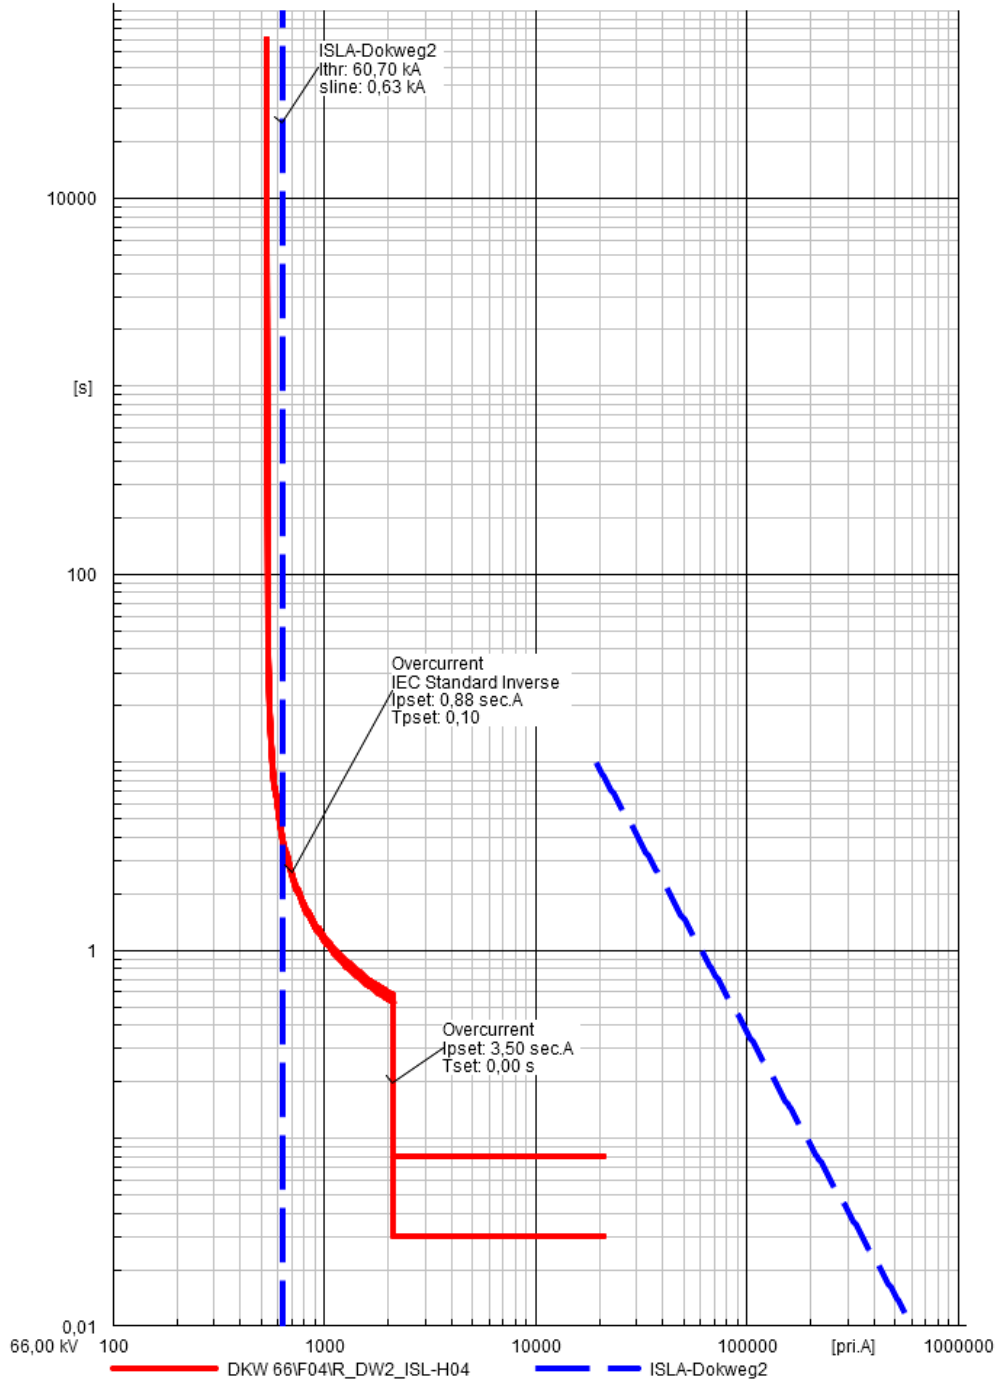
Figure 11: Overcurrent Protection (P139) Settings in Line Dokweg 66kV-Isla 66 kV [9]

The analysis of the events reveals that the main cause leading to the blackout is the activation of the overcurrent protection of the line Dokweg 66kV-Isla 66 kV, currently adjusted at 0,88\*In. This setting does not allow loading of the line above 88% of the rated current.

It is recommended to review these protection settings in order to verify if there is any justified limitation that prevents that, in steady-state conditions, rated current can flow continuously through the line. Moreover, this review should be extended to the rest of protection functions in the line Dokweg 66kV-Isla 66 kV, as well as the other transmission lines in Aqualectra power system.

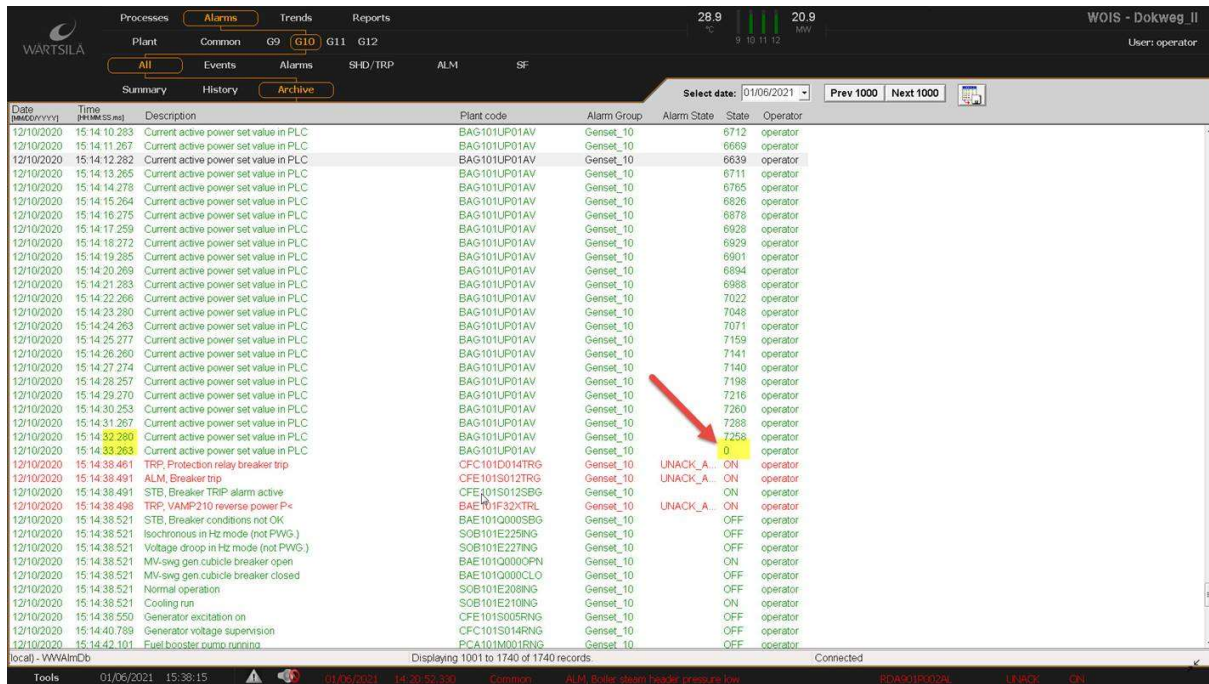
Engine ramping down. This has been UNIC setpoint in Isochronous. After this generator breaker trip from reverse.

Figure 6 setpoint went to zero before breaker trip.

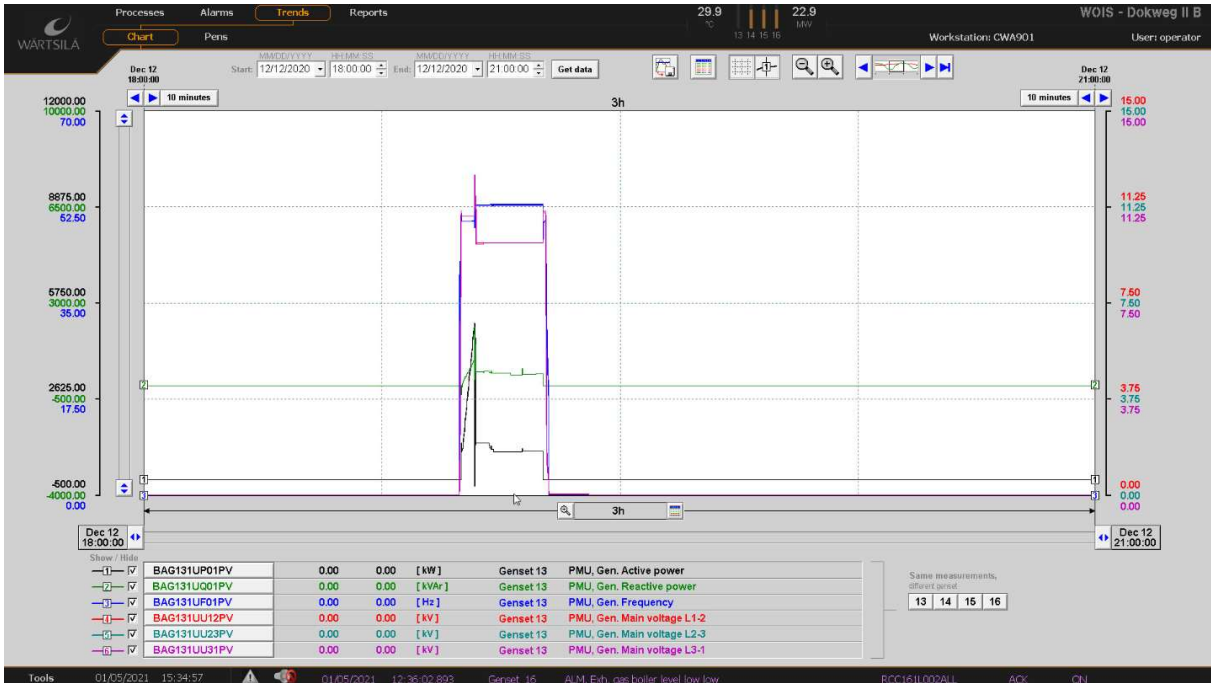
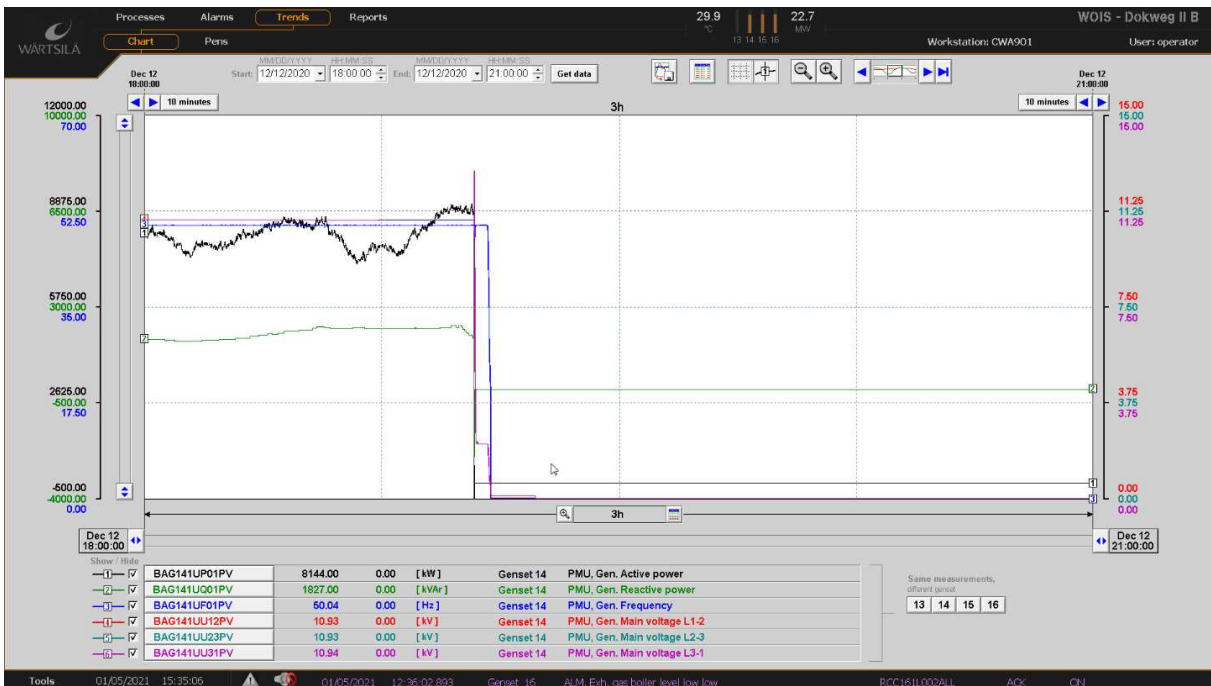
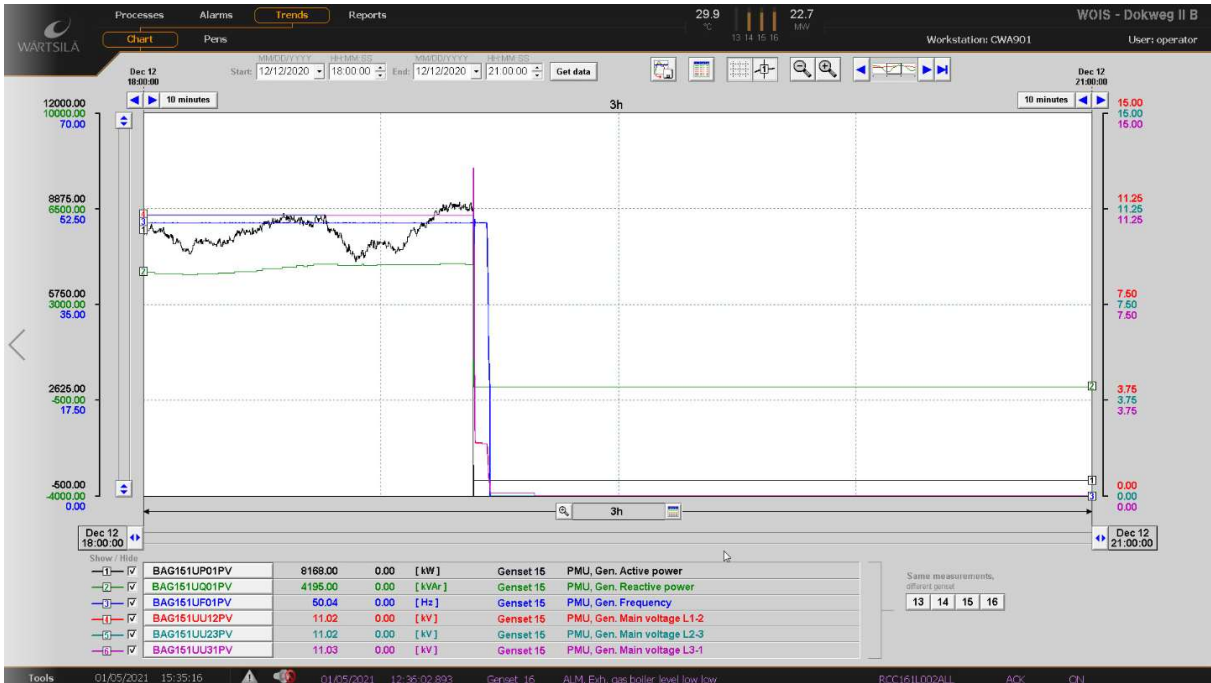
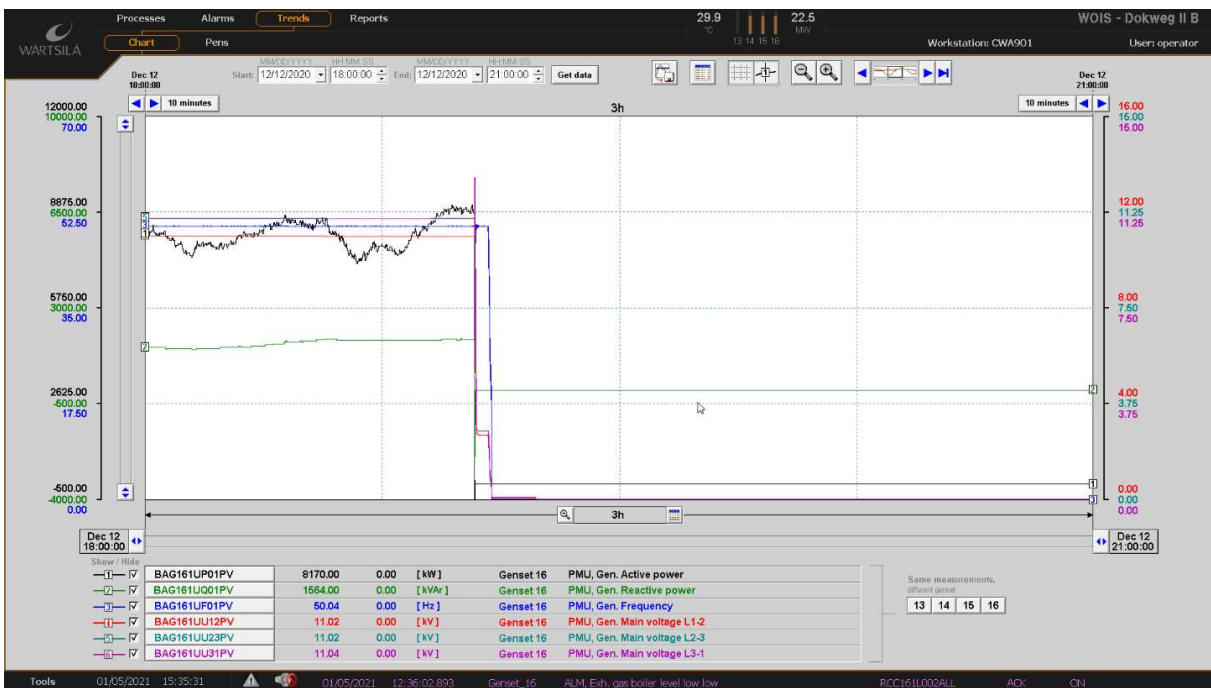
12/12/2020	19:03:15.057	Water booster unit pump 2 running	VBD902M002RNG	Common	OFF	operator	
12/12/2020	19:03:15.057	Water booster unit pump 2 running	VBD902M002RNG	Common	OFF	operator	
12/12/2020	19:03:17.375	ALM_Generator protection relay breaker trip	BAE161D014TRG	Genset_16	UNACK_ALM	operator	
12/12/2020	19:03:17.405	TRP_Gen breaker trip circuit indication	CFC161S012TRI	Genset_16	UNACK_ALM	operator	
12/12/2020	19:03:17.405	STB_Breaker trip indication	CFC161S012SBI	Genset_16	ON	operator	
12/12/2020	19:03:17.409	TRP_VAMP210 reverse power P<	BAE161F32KTRL	Genset_16	UNACK_ALM	operator

According received information it seems that December 12, 2020 problems start from grid event. After grid event units try to balance frequency and were ramping down until reverse protection trip generator breakers.

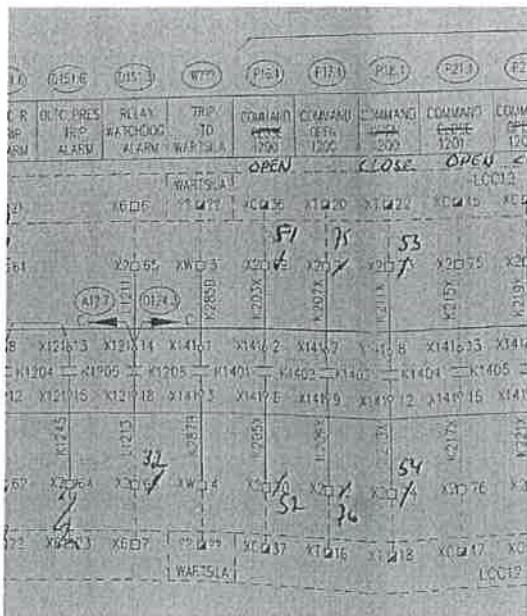
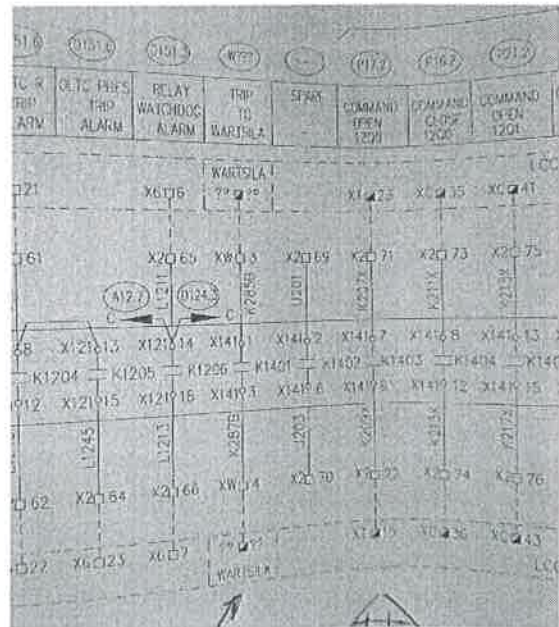
- 5- When the circuits were compared, a difference was found in the wiring. Please refer to the below photos. At feeder F03 the relay contact K1402 was wired to a trip contact. The second photo shows the As Built version of feeder F05 / F12 which shows contact K1402 as "Spare".
- 6- When an alarm is received from the GIS local control panels (LCC), if the control is set in the "Remote" position, the relay contact K1402 will cause the trip of the 66kV circuit breaker. This event was repeated by us with the feeder that is out of service. No other comparison were carried out between original project (F05/F12) and modification in 2018.

As built drawing by Aqualetra modification 2018

As built drawing original by K-Line 2014

With regards to the tripping of the 66kV circuit breaker of the feeder F03 (Transformer #3) it should be pointed out that due to a wiring error, a regular alarm originated in the GIS control panel (LCC) sent a trip signal to the c. breaker.

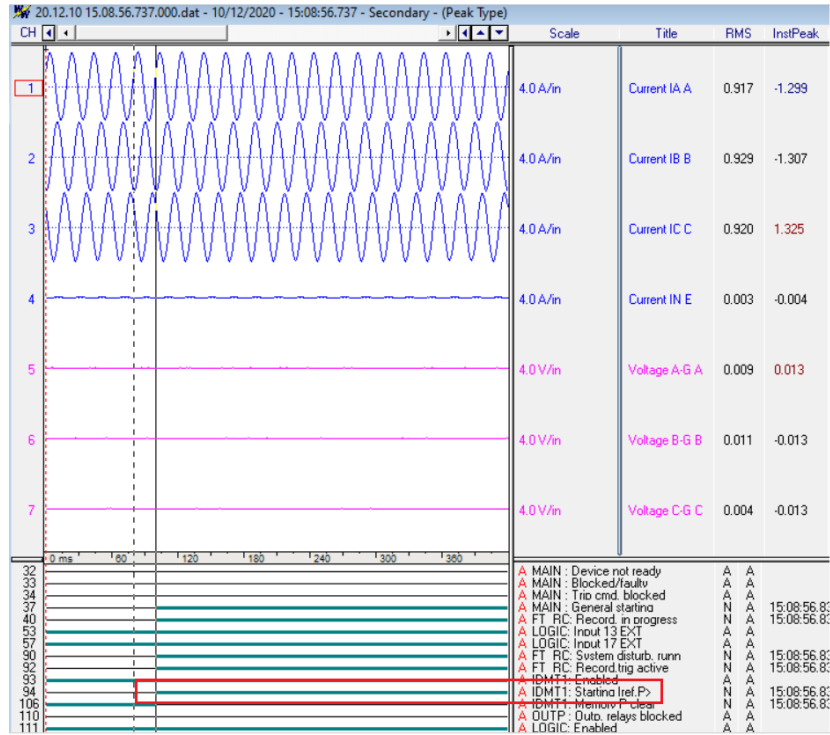
Figure 1 - P139 Disturbance record of Dec 10th 2020

The two relays on the 66kV Isla substation did not register any relevant events for the dates in question (December 10<sup>th</sup>, December 12<sup>th</sup> and January 4<sup>th</sup>), therefore we concentrated our efforts in the relays of Bay 04 of the 66kV SWG. Upon analysis, we can see that on the dates of December 10<sup>th</sup>, 12<sup>th</sup> and January 4<sup>th</sup>, the P139 triggered a disturbance record that shows that the IDMT overcurrent function picked up:

The current value on all three occasions when the IDMT function picked up was around 0.928 A secondary, which is 556.8A primary given that the CT is 600:1. When we see the settings of the IDMT function, we can see that the Iref P> value is 0.88\*Inom (Inom = 600A) which is 528A:

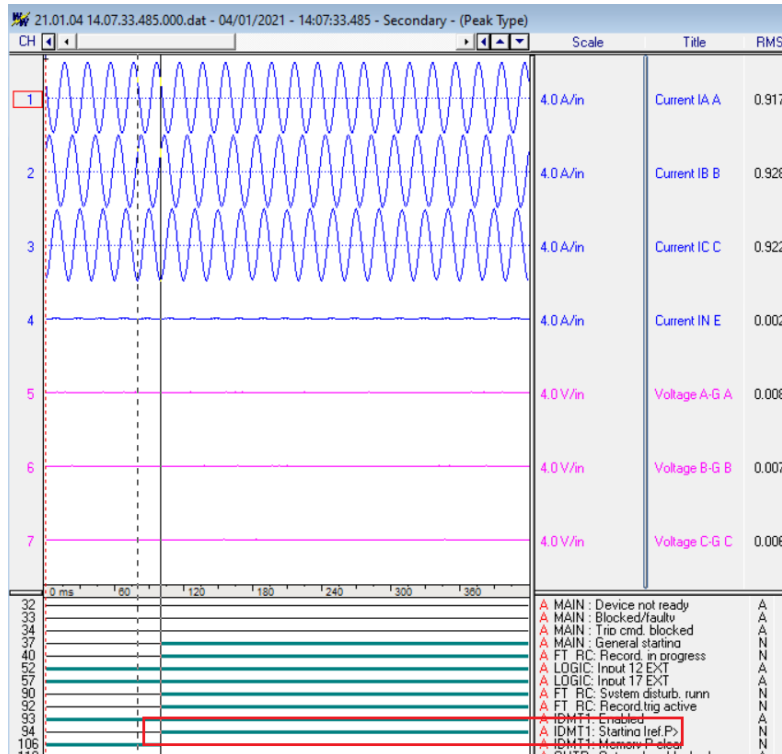
Figure 3 - P139 Disturbance record of Jan 4th 2021

- 4- It was verified that the Feeder F04 tripping events of 10 and 12 of December 2020 and 4 January 2021, were started by a high current detected by overcurrent relay P139. As a result of this situation, Aqualectra have decided to inhibit the delayed overcurrent setting of the P139 relay until a new relay study is prepared taking into consideration the changes caused by the commissioning of the new generating plant DOKWEG IIB.
